VOLUNTARY RECALL CAMPAIGN

Classification: BT24-003	Reference: NTB24-033	Date: July 1, 2024
-----------------------------	-------------------------	-----------------------

VOLUNTARY SAFETY RECALL CAMPAIGN 2024 SENTRA; WINDSHIELD INSPECTION

CAMPAIGN ID #: PMA38
APPLIED VEHICLES: 2024 Sentra (B18)

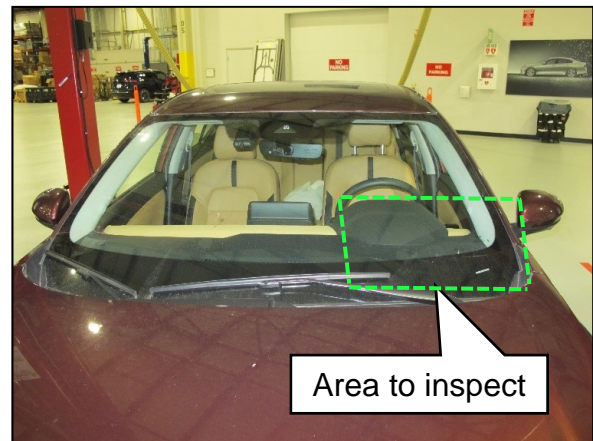
Figure 1

1. Locate the lower driver (LH) side area of the windshield for inspection.

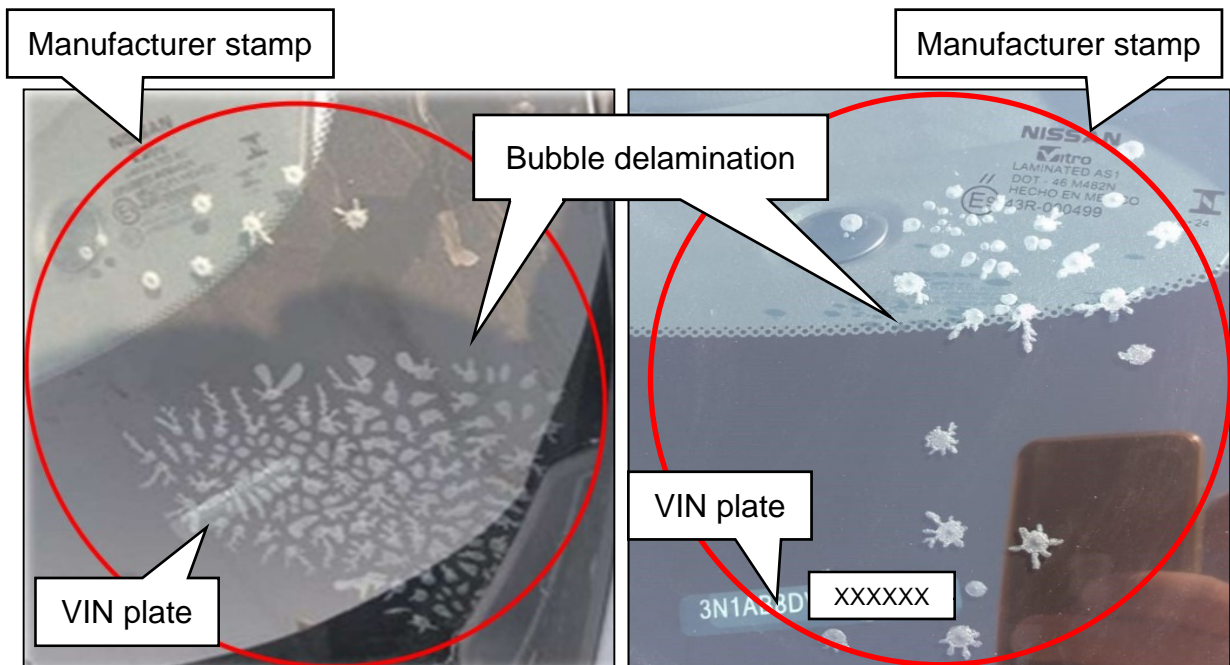
2. Clean the windshield with glass cleaner and a clean towel before inspection.
3. Inspect for bubble-type delamination (Figure 2 and Figure 3).

4. Does the lower driver (LH) side area of the windshield have bubble-type delamination as shown in Figure 2 and Figure 3 on page 2?
- Document the results on the repair order.

5. Replace the windshield.
- Refer to the ESM: **BODY EXTERIOR, DOORS, ROOF & VEHICLE SECURITY > GLASS & WINDOW SYSTEM > REMOVAL AND INSTALLATION > WINDSHIELD GLASS > Removal and Installation**
 - Follow all Warnings and Cautions in the ESM related to windshield replacement.
