U.S. Department of Transportation  
**National Highway Traffic Safety  
Administration**

**Subject:** Loss of Drive Power from Damaged Charging Unit

# Technical Service Bulletin

**SUBJECT:** DTC P1A9096 CHECK FOR ICCU & FUSE REPLACEMENT & ICCU SOFTWARE UPDATE (RECALL 257)

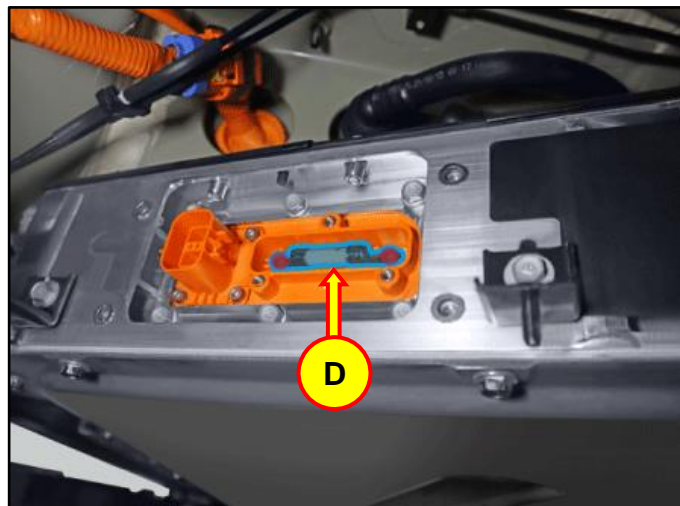
There can be difficulty removing the fuse, which may include the nuts of the at the back of the fuse holder falling back into the battery.

1. Remove:
  - 6 qty. 10mm bolts (Green marked),
  - 4 qty. bolts by Allen wrench (Red marked).
2. Push in bottom area. Pull out top area.
3. Reach in and grab the nut behind the plate on the bottom surface.
4. Hold the nut at the back side.
5. Install the fuse bolt at the place that the nut had dropped.
6. Install all the other bolts in reverse order of removal.
7. Install the rest of the fuse bolts.

**NOTE:** Contact Techline if the above procedure did not resolve a dropped nut problem.

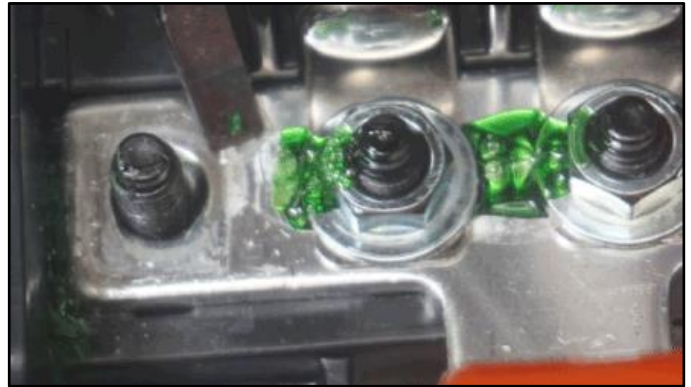
Any foreign substance in this area may cause poor contact between terminals.

- D4. After removing the fuse carefully clean the fuse mating surface prior to installation.
