Part 573 Safety Recall Report

23V-700

Manufacturer Name : BMW of North America, LLC

RECALL 23V-XXX: STEERING WHEEL GROUND CONNECTION

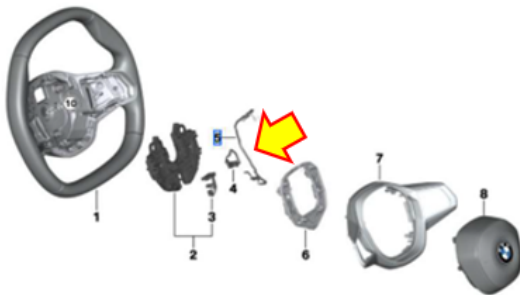
A ground wire might not be properly fastened in the steering wheel. This can cause a loose connection which indicates hands are ON the steering wheel even when being driven with hands-off.

Remove the steering wheel airbag. Check the ground wire at the steering wheel horn pad bracket for correct tightness and lack of movement.

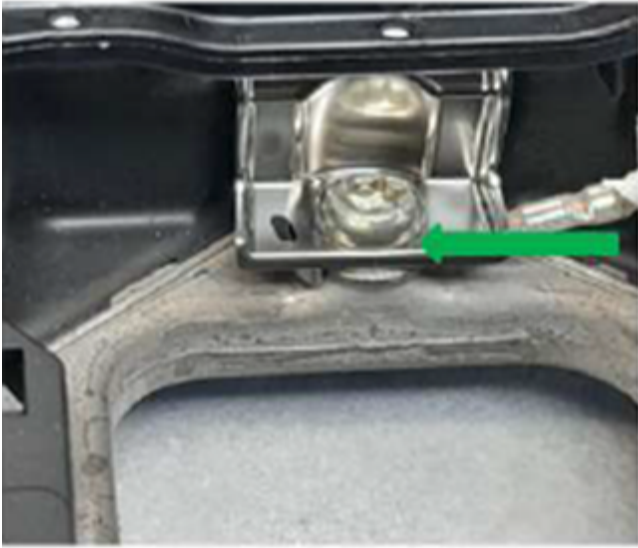
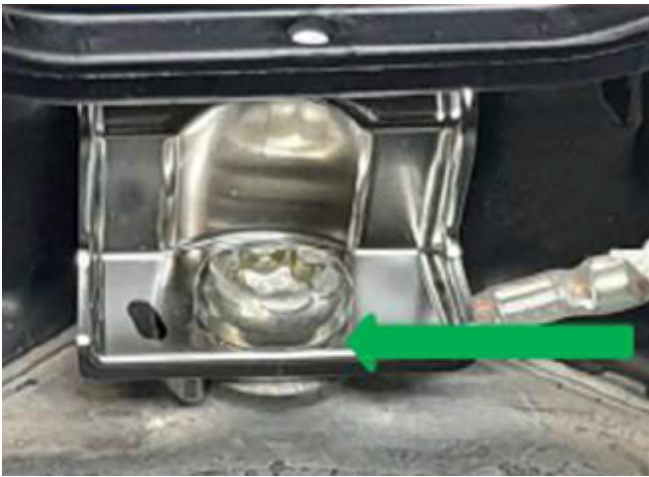
3. If the ground connection screw is not in contact with the horn plate bracket upon visual inspection but is tight and at the correct torque spec (2.5 Nm +/- 5 Nm), the screw must be removed, and the threads need to be inspected for any burr formations.

Add two (1 mm) thick washers under the screw head, then tighten screw to (2.5 Nm +/- 5 Nm).
