# MAZDA AUSTRALIA PTY. LIMITED

## - Mazda CX-60 (KH), CX-90 (KK)

Recall number	REC-005882
Campaign number	R202401
Original published	30 January 2024

# Part 573 Safety Recall Report

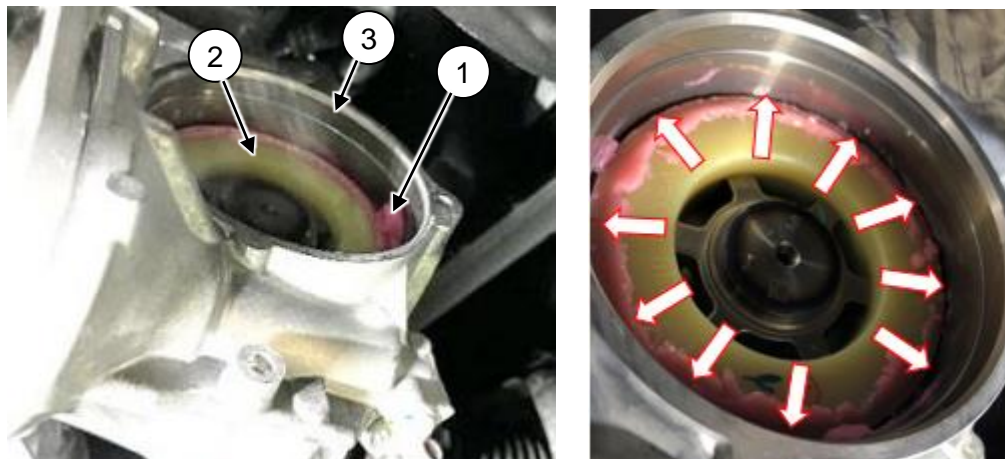
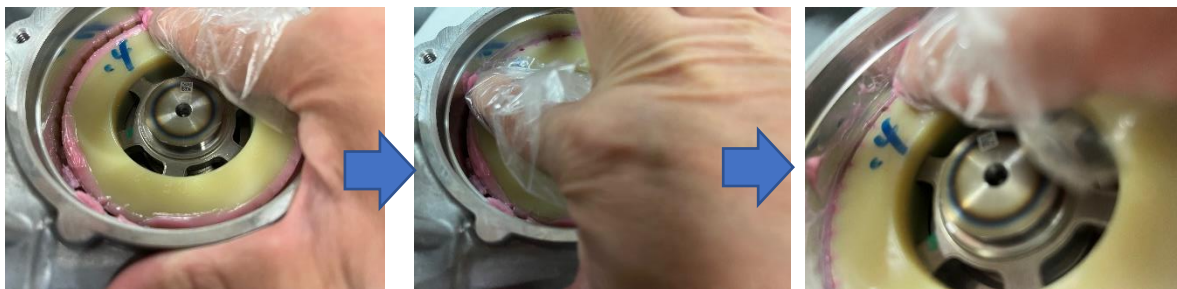
**NOTE:** There are variations in the amount of the grease attached to the worm wheel. Even if the amount is small, perform this procedure.

Push the protruded grease (pink) (1) into the gap between the worm wheel (2) and the housing (3) with a finger covered with the new glove as per the following image.

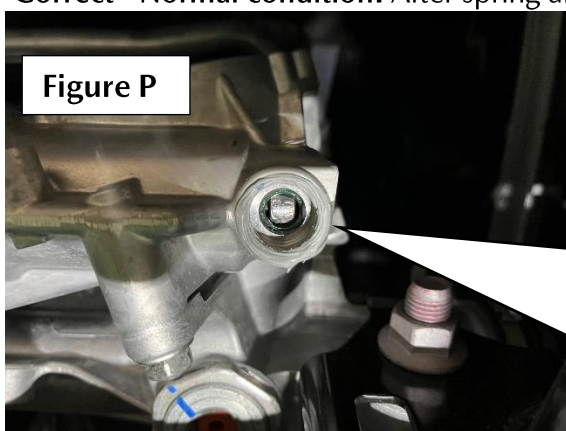
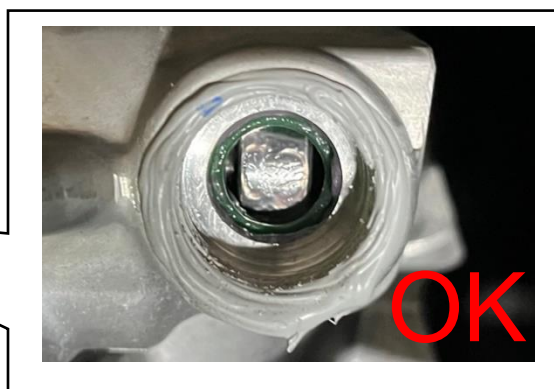
**Correct - Normal condition:** After spring and cap are removed.

14. Clean off a medium or long needle nose pliers and remove the spring and/or cap inside if needed. The tool must be cleaned to prevent any contamination. Visually inspect the inside and make sure that there are no springs and caps.

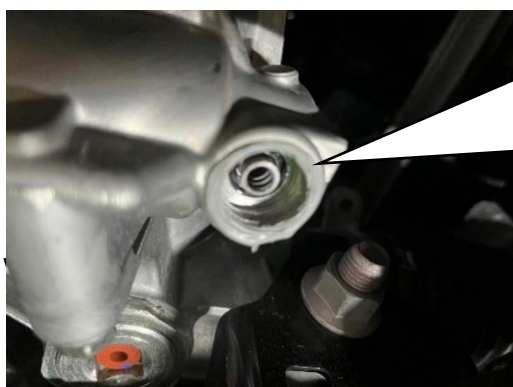
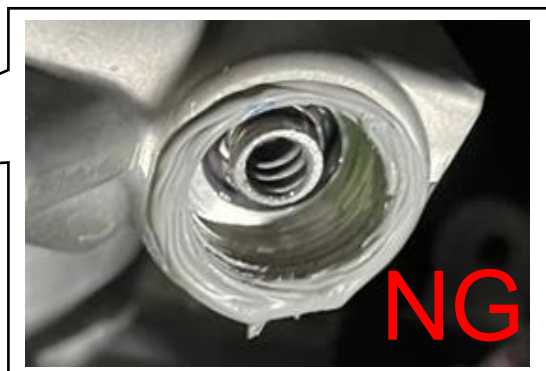
**NO GOOD – Incorrect condition:** Spring is not removed

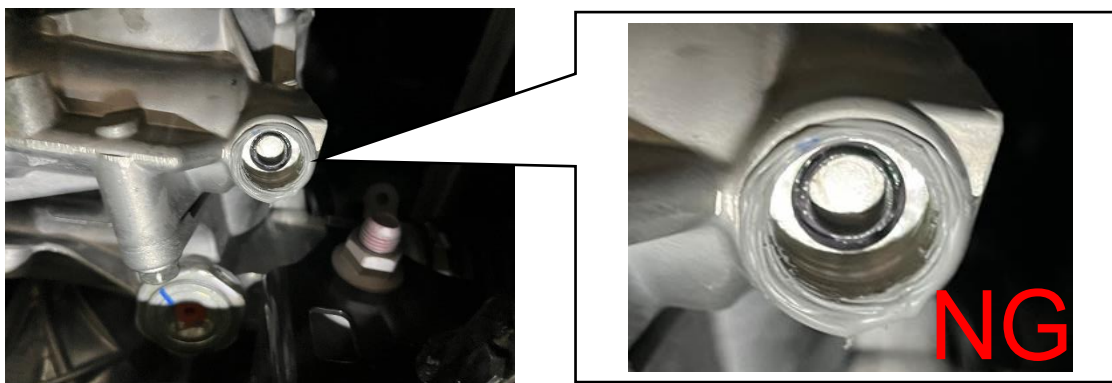
NO GOOD (NG) – Incorrect condition: Cap is not removed

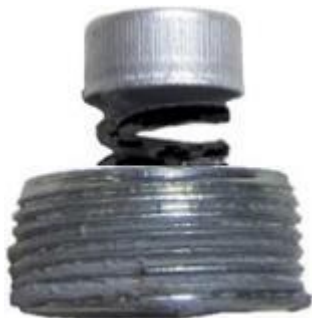
--	The spring seat is placed upside down.	The spring and the spring seat are reversed.

➤ Position and direction of the spring and spring seat
