# ODI RESUME

**Investigation:** PE24009  
**Prompted By:** VOQ Review  
**Date Opened:** 03/27/2024  
**Investigator:** Jacob Ebert                      **Reviewer:** Joshua Neff  
**Approver:** Tanya Topka  
**Subject:** 2022 RAM Transmission Snap Ring Failure

**NUMBER:** 21-002-23

K1 Clutch Snap Ring Repair

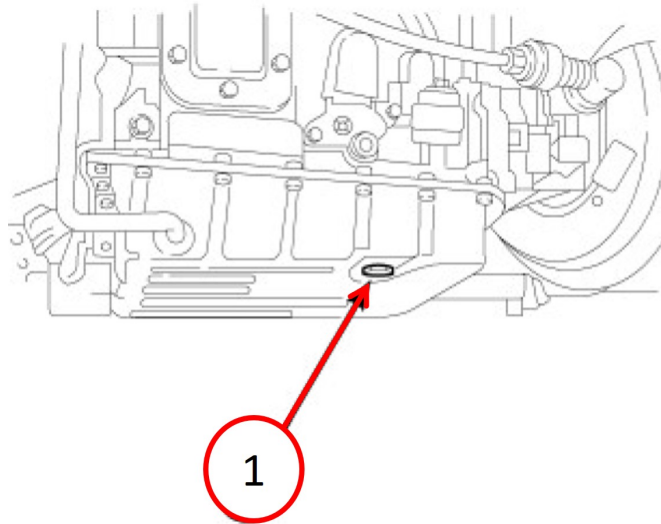
**Fig. 1**  
**Oil Pan Drain Plug**

1 - Plug

1. Remove the transmission. Refer to the detailed service procedures available in DealerConnect/ Service Library under: 21 - Transmission and Transfer Case / Automatic - AS69RC / Removal.
2. Place the transmission manual shift lever into the park lock position.
3. Plug all openings and clean exterior of transmission with water soluble solvent or a pressure washer.
4. Remove oil pan drain plug (Fig. 1) and drain fluid from transmission.

- 36. Re-install oil pan drain plug with new supplied gasket (Fig. 1) .
- 37. Using new torque converter bolts, install the transmission. Refer to the detailed service procedures available in DealerConnect/Service Library under: 21 - Transmission and Transfer Case / Automatic - AS69RC / Installation.
- 38. Using wiTECH, perform a Quick Learn Procedure.

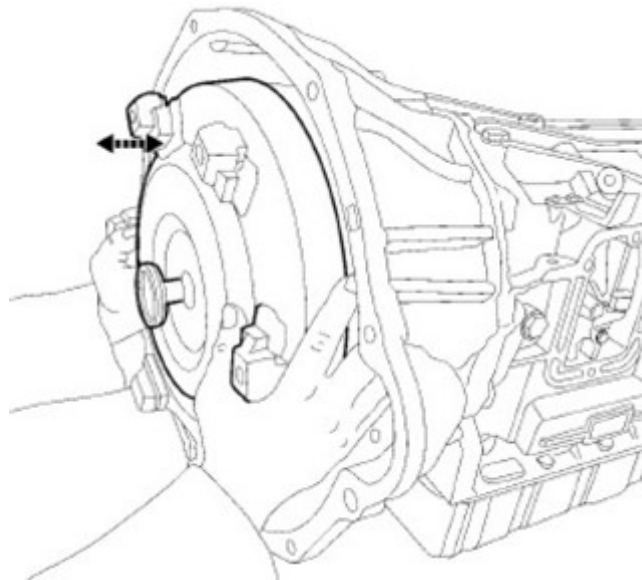
**Fig. 2**  
**Removing Torque Converter**

5. Remove the torque converter from the transmission (Fig. 2) .

34. Install the torque converter onto the input shaft while applying inward pressure and rotating back and forth at the same time in order to align the input shaft splines and the two teeth on the oil pump drive gear (Fig. 2) .

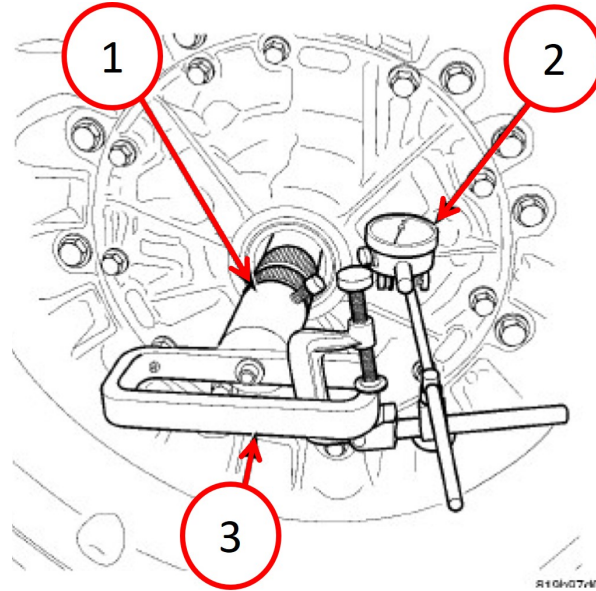
Fig. 3

- Using Adapter Socket, End Play 8266-22 and the handle from End-Play Tool Set 8266B and Dial Indicator C-3339A, measure and record the input shaft end-play (Fig. 3) .

Recording The Input Shaft End-Play

- 1 - 8266-22
- 2 - 8266B
- 3 - C-3339A

**NOTE: Gear train end play is a critical pre-disassembly check to help determine the condition of the transmission. End play reading greater than specification (larger gap) indicate that a bearing or thrust plate is either missing, worn or has disintegrated, in which case there will be debris in the oil pan.**

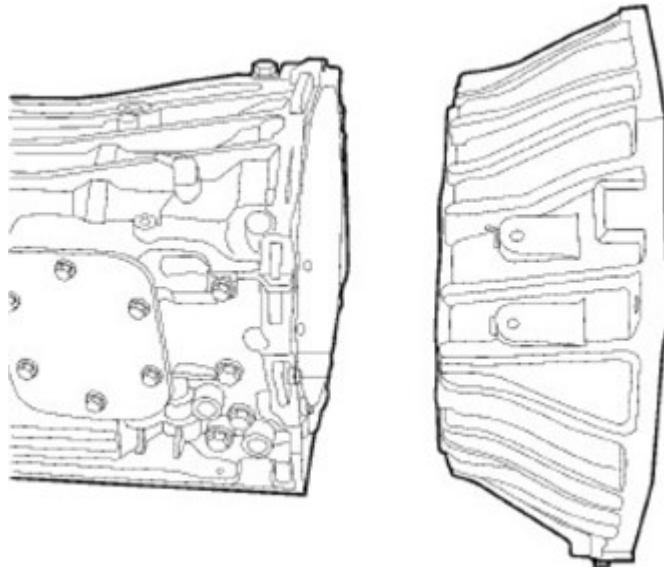
**Fig. 4**  
**Torque Converter Housing And Transmission Case**

7. Remove the bolts securing the torque converter housing to the transmission case and remove the housing (Fig. 4) .

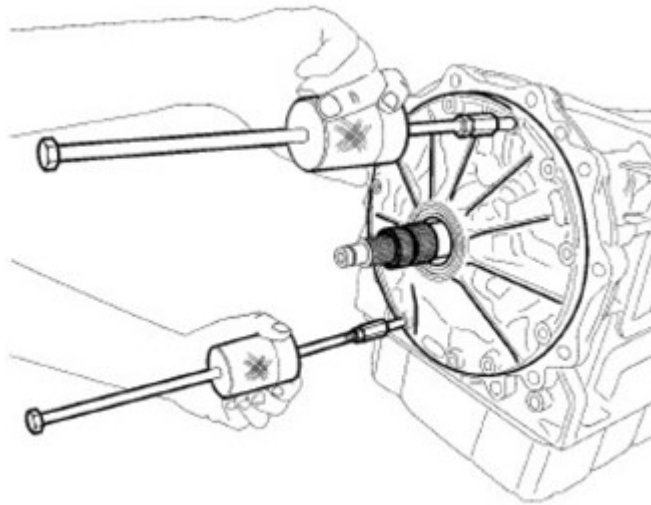
**Fig. 5**  
**C-3752 And Adapters 9981**

8. Remove the bolts securing the oil pump to the transmission case and use C-3752 and adapters 9981 to remove the oil pump (Fig. 5) .

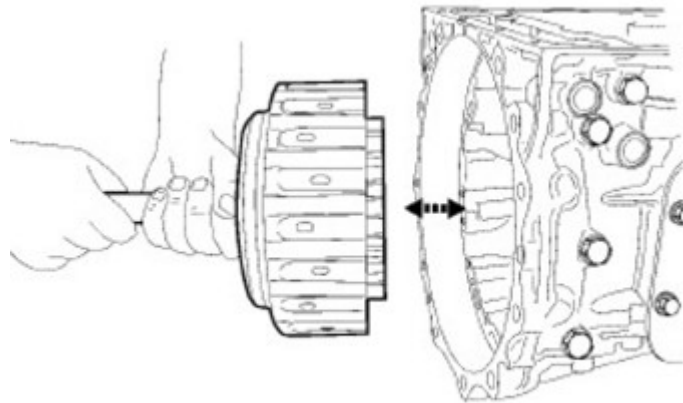
Fig. 6  
K1 And K2 Clutch Assemblies

9. Remove the input shaft assembly with the K1 and K2 clutch assemblies attached (Fig. 6) .  
**NOTE: If the K1 snap ring has become dislodged, the K1 clutch assembly will not come out as a complete unit.**

22. Install the K2 clutch assembly and the K1 clutch/input shaft assembly into the transmission case (Fig. 6) .

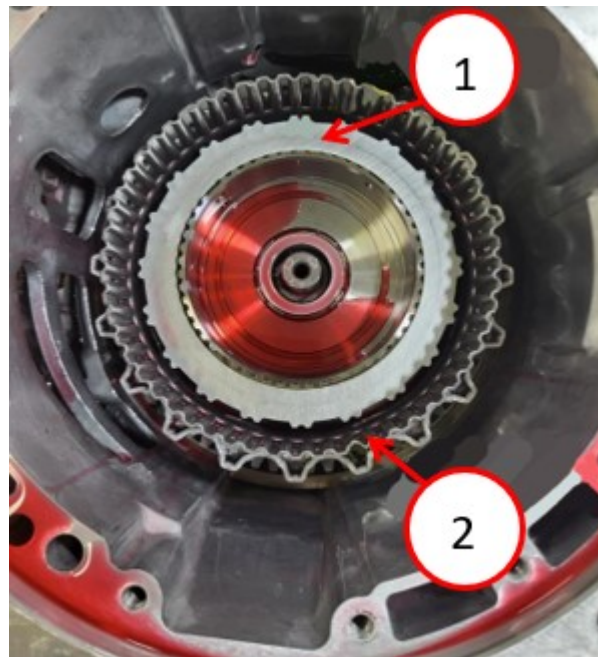
Fig. 7  
K1 Snap Ring Dislodged

10. Is the K1 snap ring dislodged (Fig. 7) ?

**NOTE: K1 snap ring dislodge will result in some loose clutch discs/plates remaining inside K2 clutch hub upon removal of the K2 and K1 clutch assemblies.**

- 1 - K1 Clutch Pack  
2 - K2 Clutch Hub
-

- YES>>> Proceed to [Step 12](#).
- NO>>> Proceed to [Step 11](#). **Additional diagnostics are required to determine the root cause. Replace the snap ring to ensure reliability and performance of the transmission.** Use Snap Ring Replacement LOP.

- a. Remove installed Snap Ring from K1 Clutch Assembly Drum.
- b. Replace snap ring in K1 Drum with replacement part P/N 68269568AB snap ring. Be sure to install so that the snap ring ends are covered in the groove by drum "teeth" (not installed such that ends are in open spaced of the groove).
- c. Proceed to [Step 22](#).

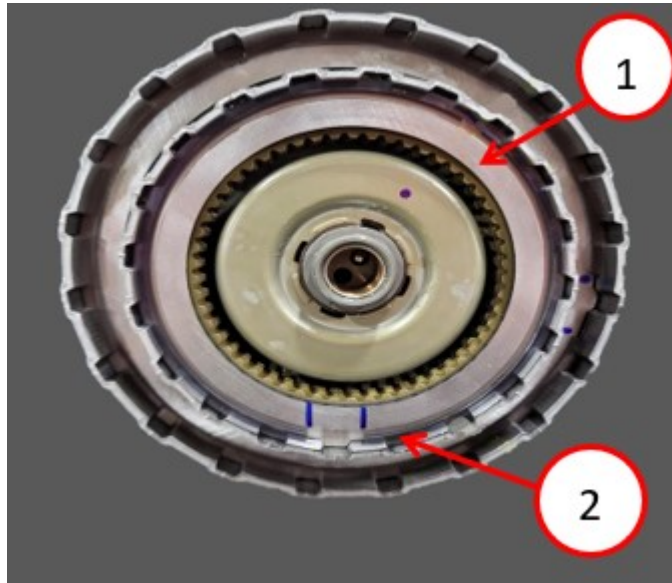
**Fig. 8**  
**Underside View Of K1 Snap Ring Correctly Seated**

**NOTE:** The K1 snap ring should be fully seated inside K1 drum groove. K1 clutch pack should remain inside K1 assembly (**Fig. 8**) .

1 - K1 Clutch Pack  
2 - K1 Snap Ring

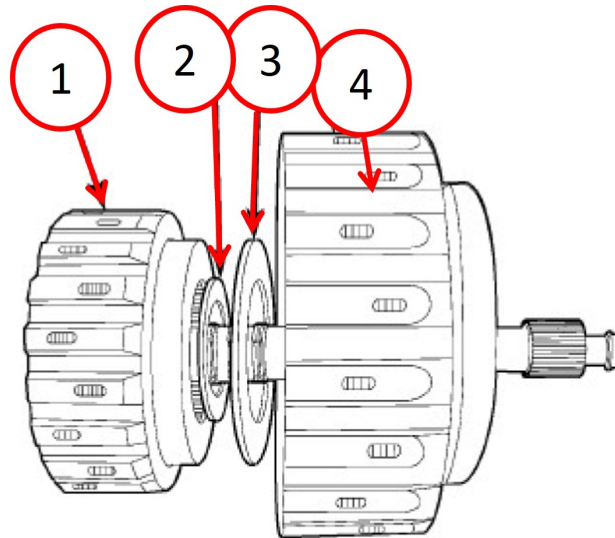
**Fig. 9**  
**K1 And K2 Clutch Assemblies**

12. Remove the K2 clutch assembly and the selectable input shaft end-play thrust bearing number one and thrust washer from the K1 clutch/input shaft assembly (Fig. 9) .

- 1 - K1 Clutch/Input Shaft Assembly  
2 - Thrust Bearing Number One  
3 - Thrust Washer  
4 - K2 Clutch Assembly
-

21. Apply trans jel or petroleum jelly onto the new input shaft seal rings and install the K2 clutch assembly onto the new K1 clutch/input shaft assembly with the original selectable input shaft end-play thrust bearing number one and thrust washer in place (Fig. 9) .

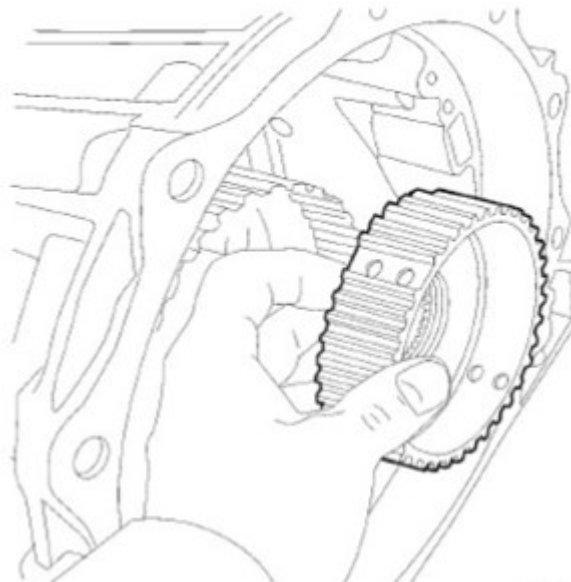
**Fig. 10**  
**K1 Clutch Hub**

13. Remove and inspect the K1 clutch hub (Fig. 10) .

20. Install the K1 clutch hub and thrust bearing into the transmission case (Fig. 10) .

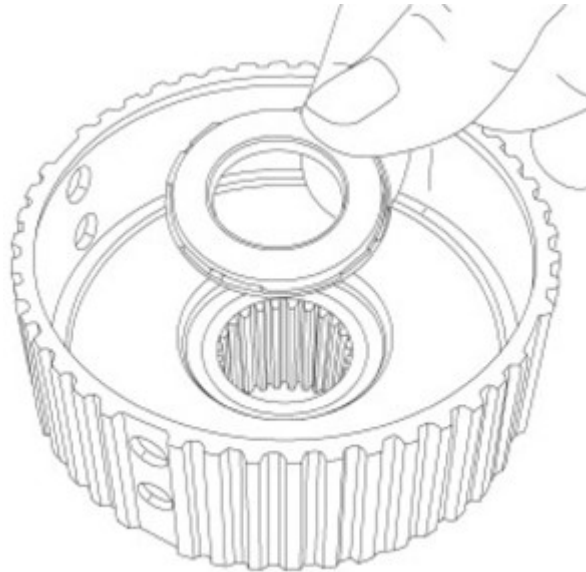
**Fig. 11**  
**K1 Thrust Bearing Number Two**

14. Remove and inspect the K1 thrust bearing number two (Fig. 11) .

19. Lubricate with trans jel or petroleum jelly and install K1 thrust bearing number two into K1 Clutch Hub (Fig. 11) .

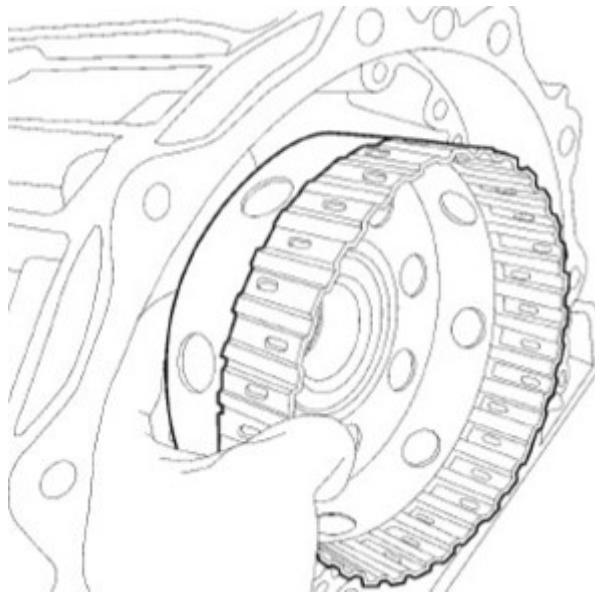
**Fig. 12**  
**K2 Clutch Hub**

15. Remove and inspect the K2 clutch hub (Fig. 12) .

18. Install the K2 clutch hub into the transmission case (Fig. 12) .

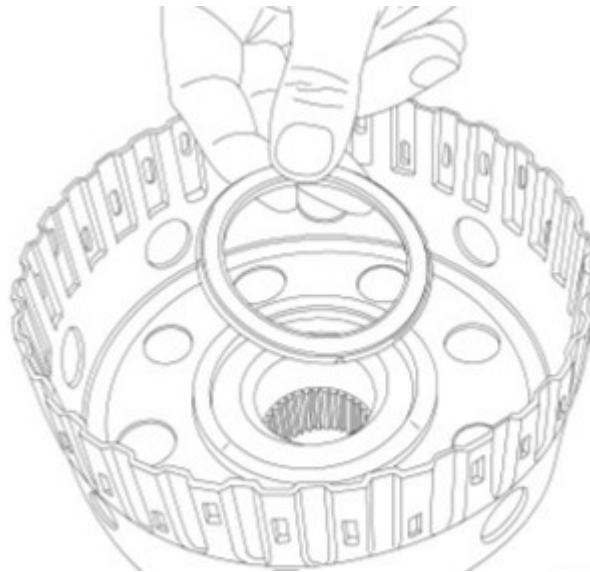
Fig. 13

17. Lubricate with trans jel or petroleum jelly and install K2 thrust bearing number three (Fig. 13) .

K2 Hub Thrust Bearing Number Three

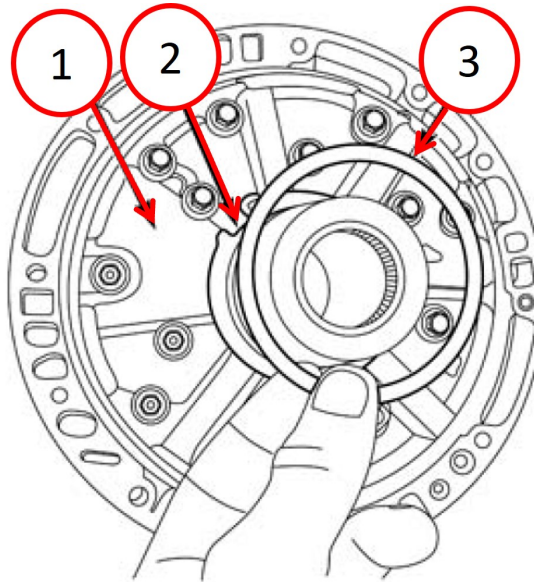
**Fig. 14**  
**Oil Pump Assembly**

23. Lubricate with trans jel or petroleum jelly and install the nylon thrust washer onto the oil pump (Fig. 14) .

**NOTE:** The nylon thrust washer is keyed to the oil pump (Fig. 14) .

- 1 - Oil Pump
  - 2 - Nylon Thrust Washer
  - 3 - Input Shaft Seal Ring
-

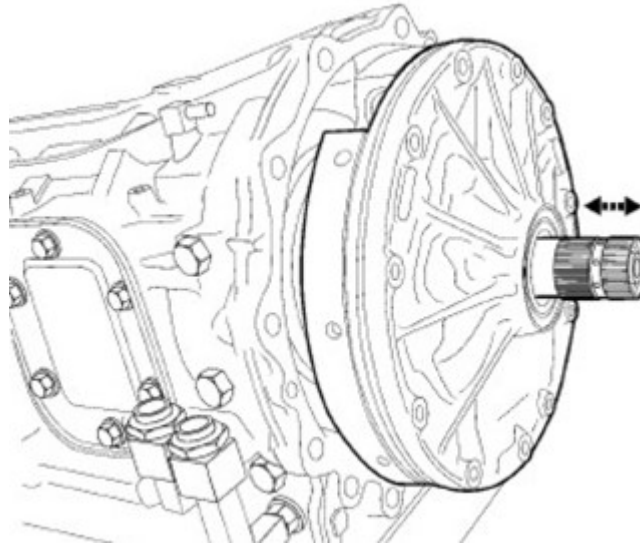
Fig. 15  
Oil Pump

25. Install the oil pump with a NEW gasket onto the transmission case (Fig. 15) .

26. Apply a light coating of MOPAR thread sealant onto the oil pump bolts and install the bolts. Tighten bolts in a crisscross pattern to 21 N·m (15.5 ft. lbs.).

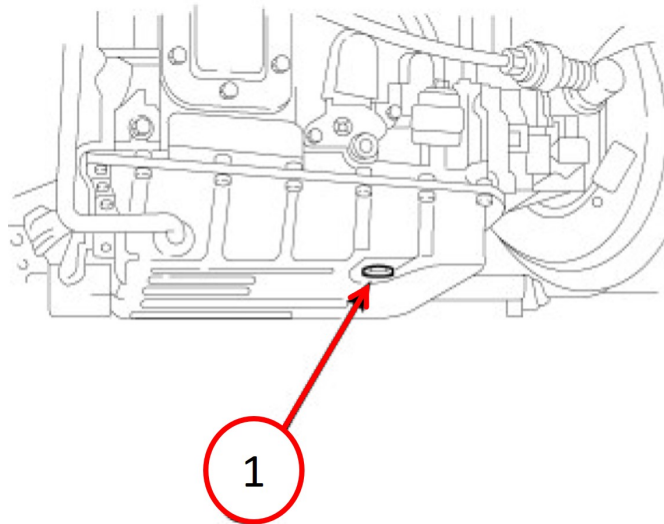
**Fig. 1**  
**Oil Pan Drain Plug**

1. Remove the transmission discarding the torque converter bolts. Refer to the detailed service procedures available in DealerConnect/Service Library under: 21 - Transmission and Transfer Case / Automatic - AS69RC / Removal. **Or** refer to the detailed service procedures available in DealerConnect/Service Library under: 21 - Transmission and Transfer Case / Automatic - AS66RC / Removal.
2. Place the transmission manual shift lever into the park lock position.
3. Plug all openings and clean the exterior of transmission with a water soluble solvent, or a pressure washer.
4. Remove oil pan drain plug (Fig. 1) and drain fluid from transmission pan. Discard drain plug gasket.

1 - Transmission Oil Drain Plug

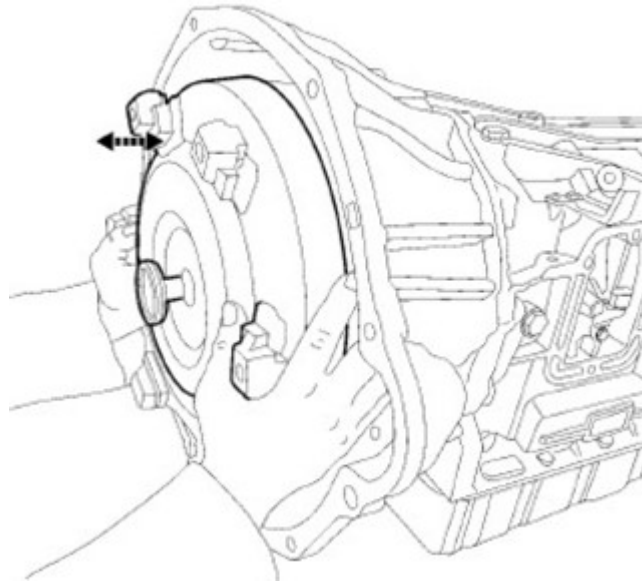
Fig. 2  
Removing Torque Converter

- Remove the torque converter from the transmission (Fig. 2) .

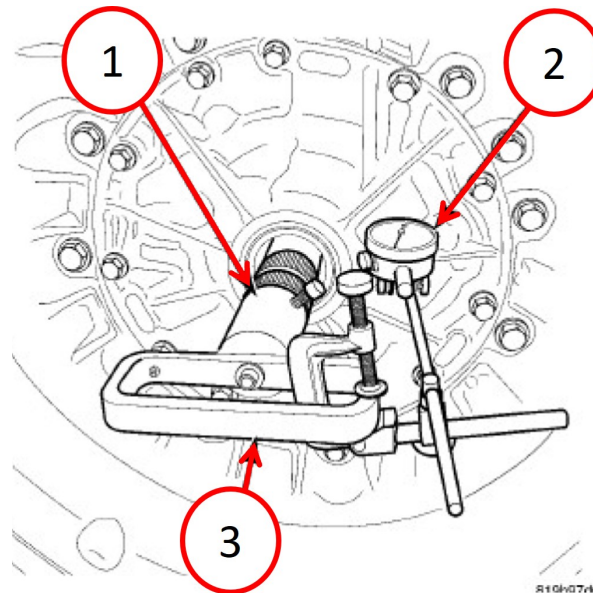
Fig. 3  
Recording The Input Shaft End-Play

- Using Adapter Socket, End Play 8266-22 and the handle from End-Play Tool Set 8266B and Dial Indicator C-3339A, measure and record the input shaft end-play (Fig. 3) .

- 8266-22
- 8266B
- C-3339A

**NOTE:** Gear train end play is a critical pre-disassembly check to help determine the condition of the transmission. An end play reading greater than specification (larger gap) indicate that a bearing or thrust plate is either missing, worn or has disintegrated, in which case there will be debris in the transmission oil pan.

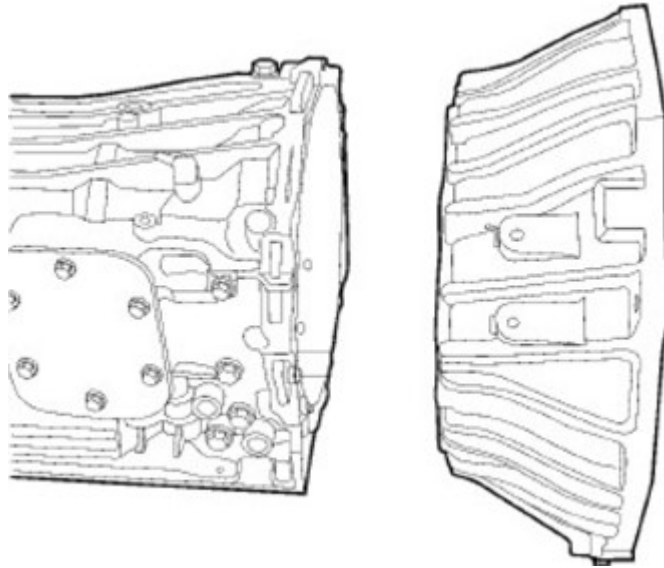
**Fig. 4**

7. Remove the bolts securing the torque converter housing to the transmission case and remove the housing (Fig. 4) .

**Torque Converter Housing And Transmission Case**

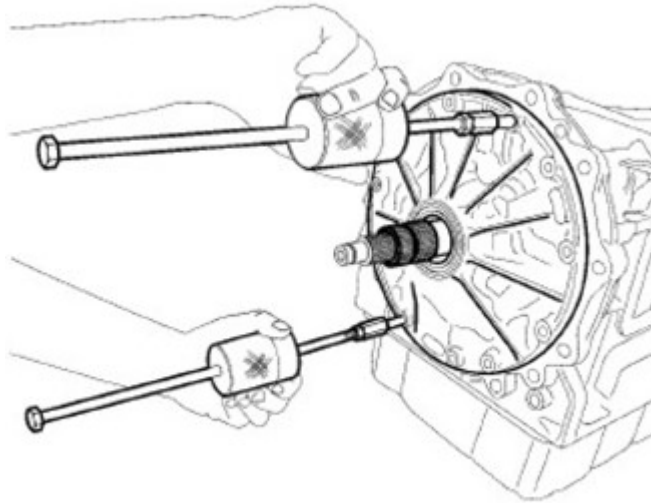
**Fig. 5**

8. Remove the bolts securing the oil pump to the transmission case and use Slide Hammers C-3752 with adapters 9981 to remove the oil pump assemble from the transmission spline (Fig. 5) .

**Slide Hammers C-3752 And 9981 Adapters**

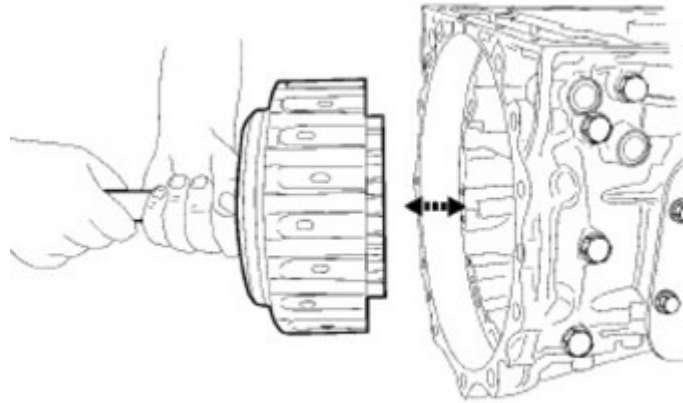
Fig. 6  
K1 And K2 Clutch Assemblies

9. Remove the input shaft assembly with the K1 and K2 clutch assemblies attached (Fig. 6) .

**NOTE: If the K1 snap ring has become dislodged, the K1 clutch assembly will not come out as a complete unit.**

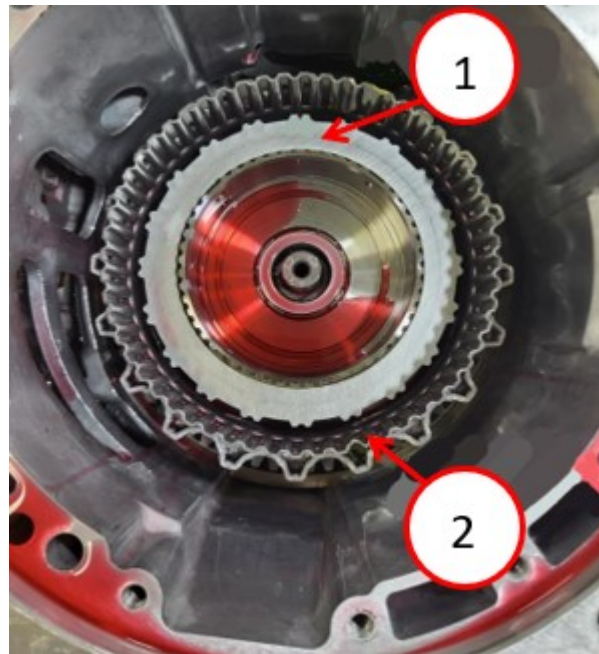
Fig. 7  
K1 Snap Ring Dislodged

**NOTE: A K1 snap ring dislodge will result in some loose clutch discs/plates remaining inside K2 clutch hub upon removal of the K2 and K1 clutch assemblies.**

- 1 - K1 Clutch Pack  
2 - K2 Clutch Hub

11. **SNAP RING REPLACEMENT PROCEDURE:**

- a. Remove the installed Snap Ring from K1 Clutch Assembly Drum.
- b. Replace the snap ring in K1 Drum with replacement P/N 68269568AB snap ring. Be sure to install so that the snap ring ends are covered in the groove by drum "teeth" (Fig. 8) (not installed such that the ends are in open spaces of the groove).
- c. Proceed to [Step 22](#).

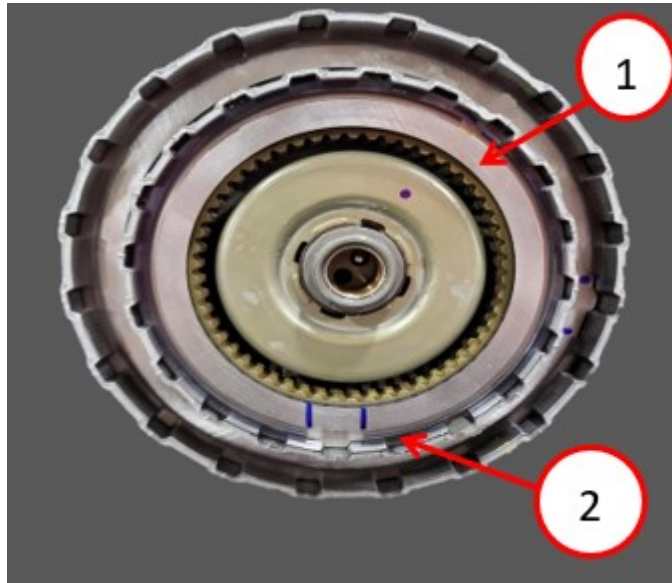
Fig. 8

**NOTE:** The K1 snap ring should be fully seated inside K1 drum groove. The K1 clutch pack should remain inside the K1 assembly (Fig. 8) .

Underside View Of K1 Snap Ring Correctly Seated

- 1 - K1 Clutch Pack
  - 2 - K1 Snap Ring
-

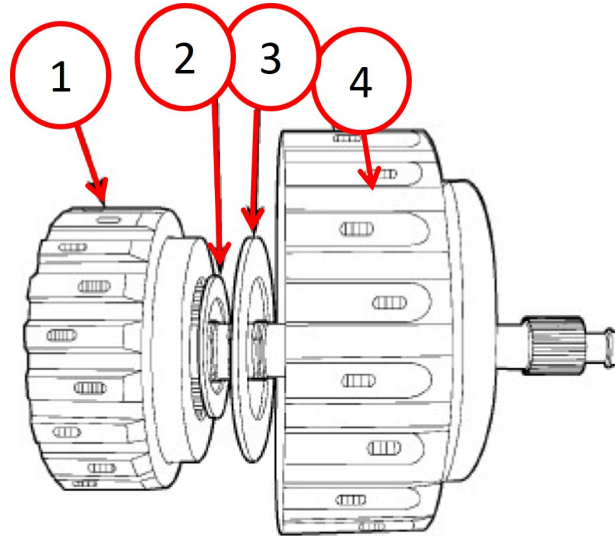
**Fig. 9**  
**K1 And K2 Clutch Assemblies**

12. Remove the K2 clutch assembly and the selectable input shaft end-play thrust bearing number one and thrust washer from the K1 clutch/input shaft assembly (Fig. 9) .

- 1 - K1 Clutch/Input Shaft Assembly
  - 2 - Thrust Bearing Number One
  - 3 - Thrust Washer
  - 4 - K2 Clutch Assembly
-

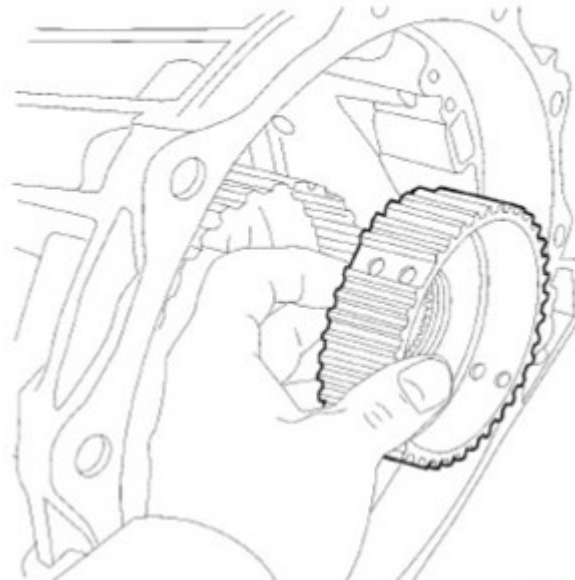
**Fig. 10**  
**K1 Clutch Hub**

13. Remove and inspect the K1 clutch hub (Fig. 9) and (Fig. 10) .

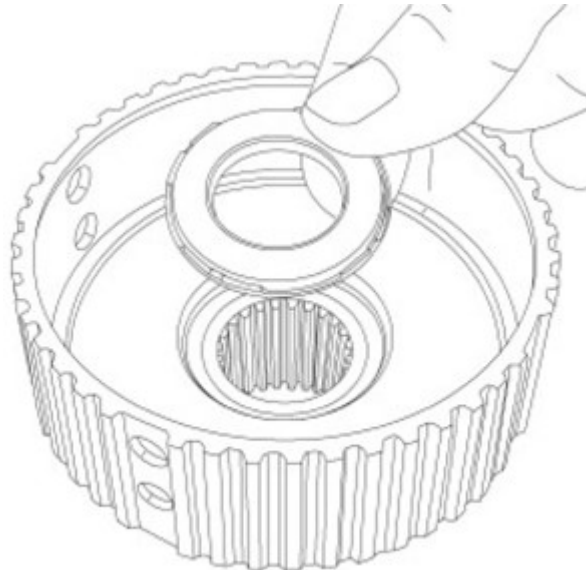
**Fig. 11**  
**K1 Thrust Bearing Number Two**

14. Remove and inspect the K1 thrust bearing number two (Fig. 11) .

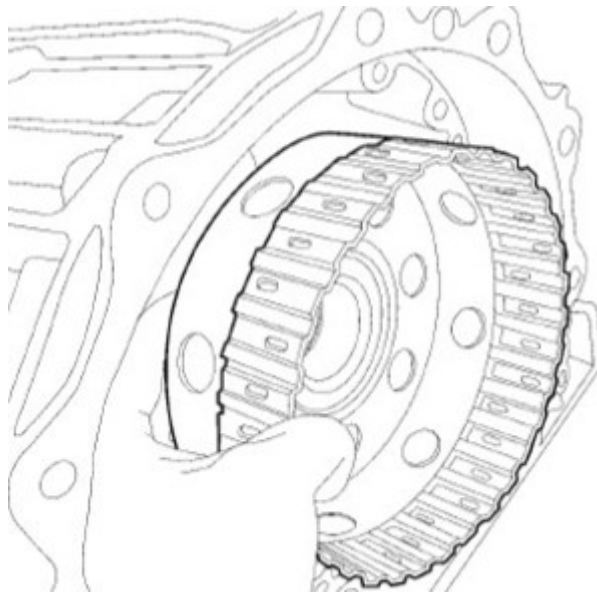
**Fig. 12**  
**K2 Clutch Hub**

15. Remove and inspect the K2 clutch hub (Fig. 12) .

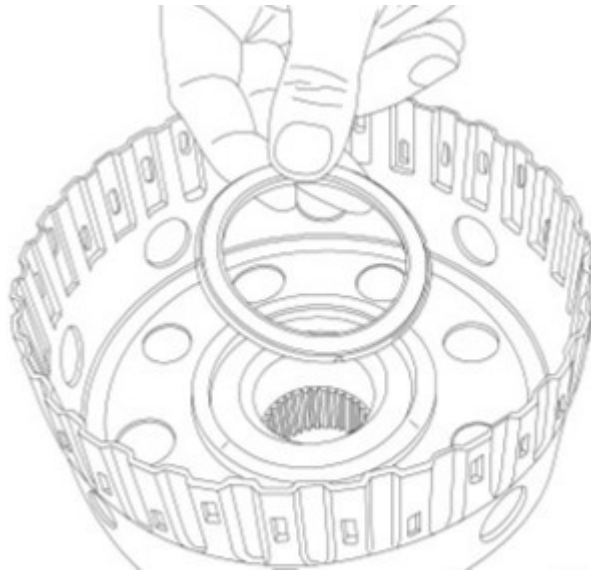
**Fig. 13**

17. Lubricate with trans jel or petroleum jelly and install K2 thrust bearing number three (Fig. 13) .

**K2 Hub Thrust Bearing Number Three**

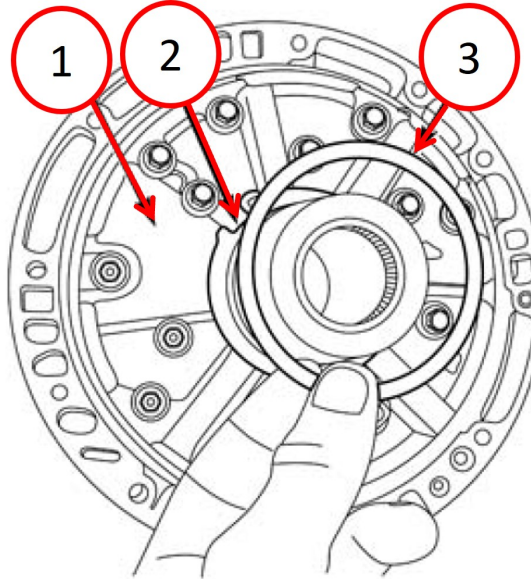
**Fig. 14**  
**Oil Pump Assembly**

**NOTE:** The nylon thrust washer is keyed to the oil pump (Fig. 14) .

**NOTE:** Two pin punches inserted through the oil pump mounting holes will aid in the installation of the oil pump (Fig. 14) .

- 1 - Oil Pump
- 2 - Nylon Thrust Washer
- 3 - Input Shaft Seal Ring

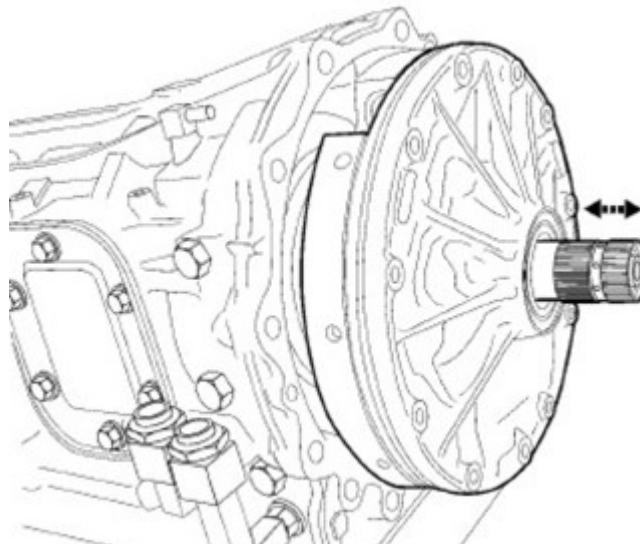
**Fig. 15**  
**Oil Pump Assembly On Transmission Spline Shaft**

25. Install the oil pump with a **NEW** gasket onto the transmission case (Fig. 15) .

26. Apply a light coating of MOPAR thread sealant onto the oil pump bolts and install the bolts. Tighten the bolts in a crisscross pattern to 21 N·m (15.5 ft. lbs.).
