# MAZDA AUSTRALIA PTY. LIMITED

## - Mazda CX-60 (KH), CX-90 (KK)

Recall number	REC-005882
Campaign number	R202401
Original published	30 January 2024

# Part 573 Safety Recall Report

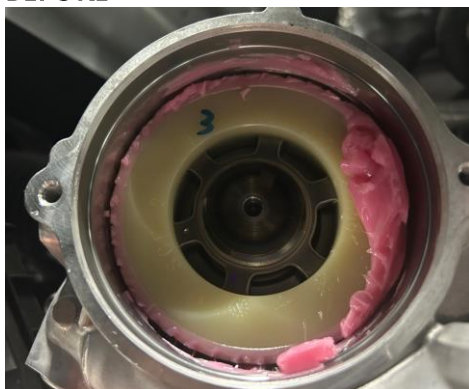
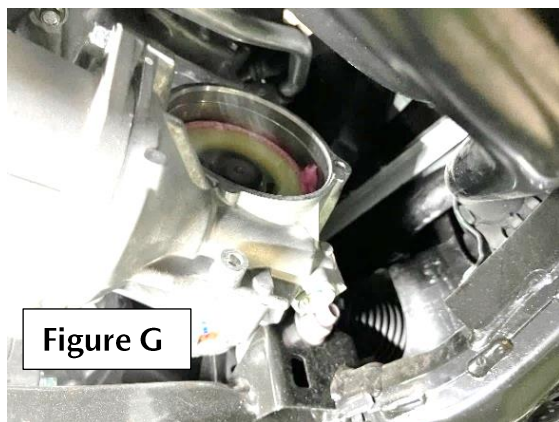
Figure G

6. Using your gloved finger, press the grease into the gap between the aluminum case and the worm gear insert around the worm gear Figure G, which adheres to the area of the blue frame in Figure H. Note G is showing a Right Hand Drive Steering Rack.

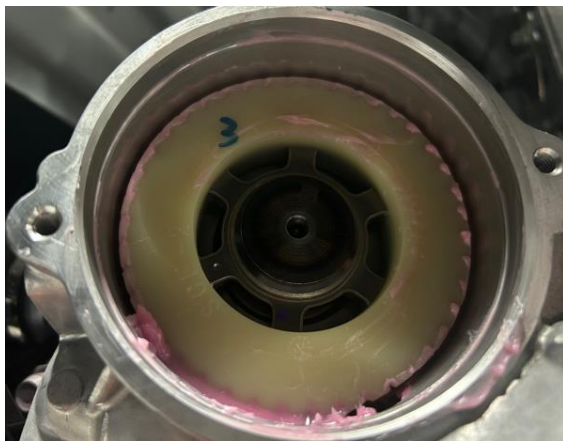
**AFTER PRESSING GREASE IN**

When you are done this is what this looks like. You can see that the plastic tool has pushed the grease into the teeth of the gear.

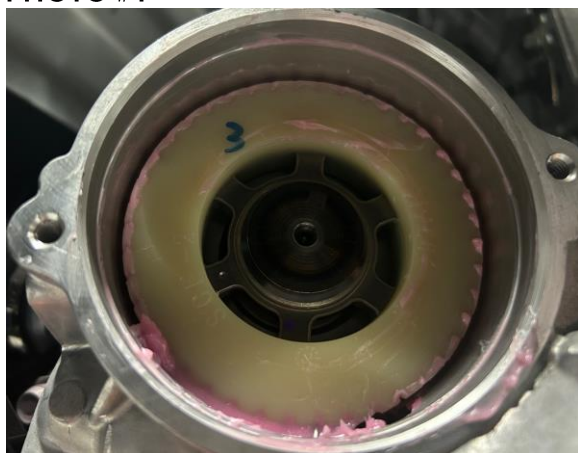
**PHOTO #1**

Take two photos, one with pink grease blended into the gear teeth and the other with the RO in the photo and RO on the gear case. The photos must be taken properly, or the warranty claim will not be approved. Make sure it is clear like the below as this will be 100% reviewed.

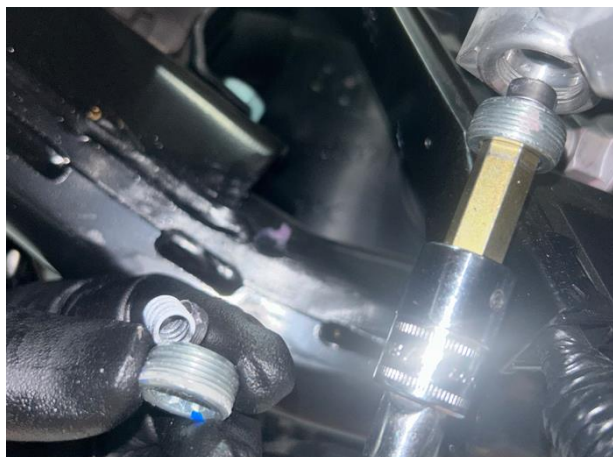
With the RO# in the photo, take a photo so that the integrated cap, spring, end cap, and old spring, which are replacement parts, are in the photo. (Note, this photo is a little low and you do not see the RO# on the rack. Make sure the RO# is present in the photo like #4

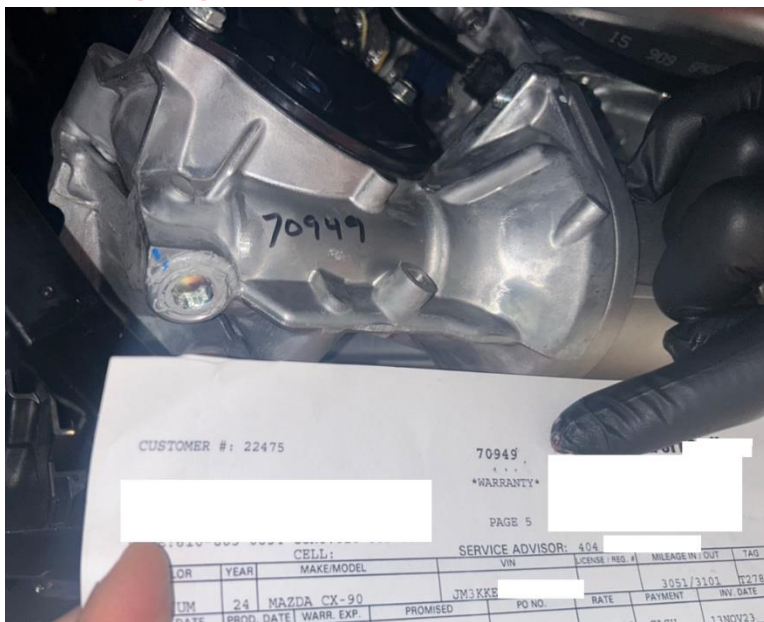
20. PHOTO REQUIREMENT #4. Take a photo for a warranty claim.  
Take a photo so that the black cover and end cap are visible.

**NOTE: THE RO ON THE CASE MUST MATCH THE RO IN THE PHOTO, THIS WILL BE CHECKED.**
