ODI RESUME

Investigation: EA23003
Prompted By: PE23-005
Date Opened: 11/29/2023
Investigator: Stefanie Oldenburg **Reviewer:** Sharon Yukevich
Approver: Tanya Topka
Subject: Momentary Increased Steering Effort

2022–23 Civic EPS Gearbox Replacement

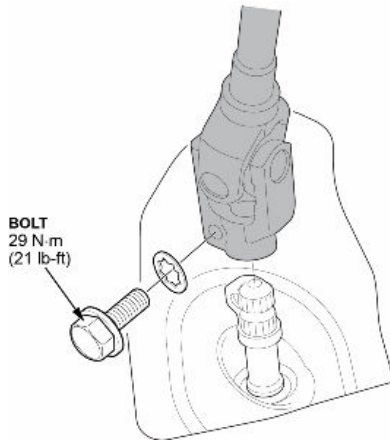
NOTE:

- Set the steering wheel straight ahead before disconnecting the shaft.
- **Do not turn** the steering wheel while disconnecting the steering joint.

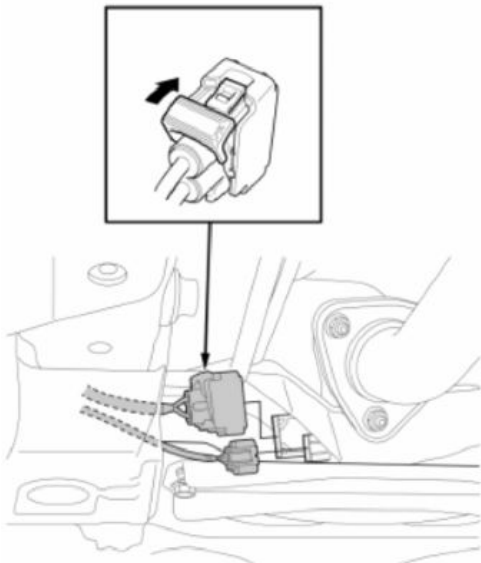
5. Remove the engine undercover.
6. Disconnect the EPS harness connectors.

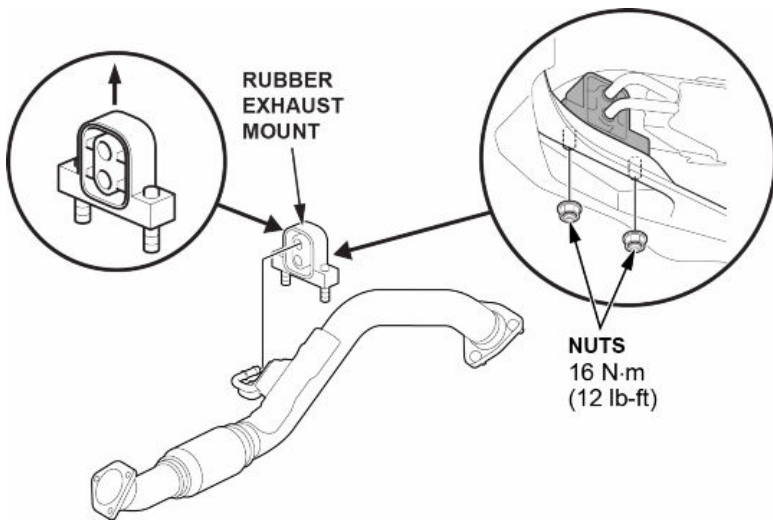
7. Remove the rubber exhaust mount.

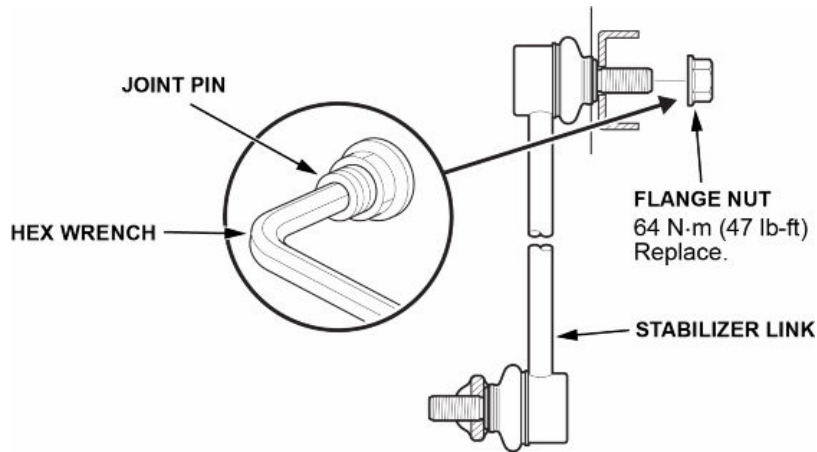
8. Disconnect the stabilizer links located on top.

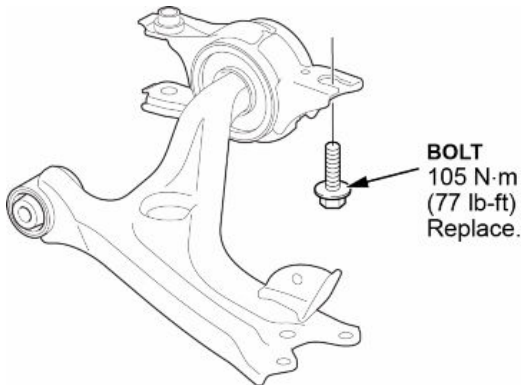
9. Remove the front lower assembly bolt (both sides).

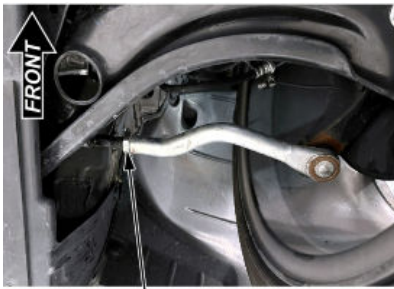
OUTER TIE-ROD NUT

10. Loosen the outer tie-rod end nut (both sides).

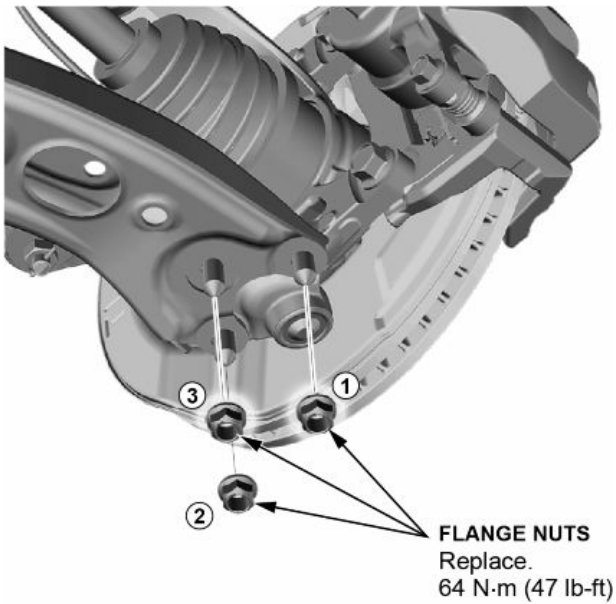
11. Disconnect the front lower arms.

NOTE: During reassembly, loosely install the new flange nuts, then tighten them to the specified torque in the numbered sequence shown.

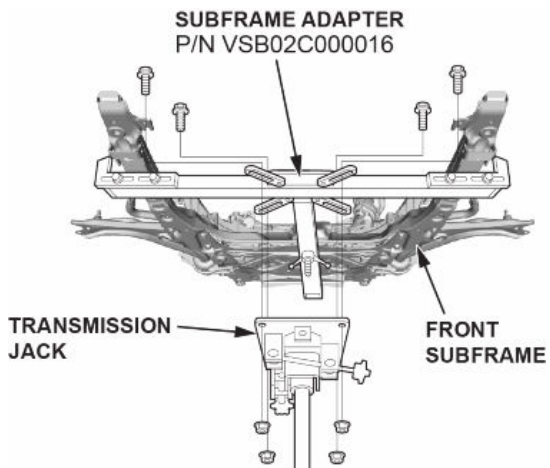
12. Remove the engine torque rod front bolt.

13. Attach the subframe adapter to the front subframe.

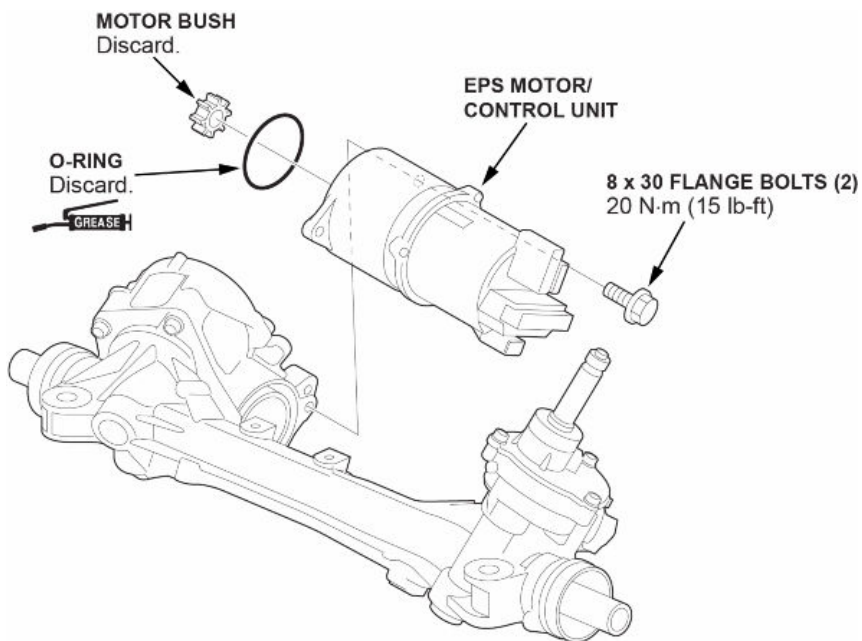
18. Remove the steering gearbox from the subframe.

19. Separate the EPS motor/control unit from the removed rack and retain for installation on the new gearbox.

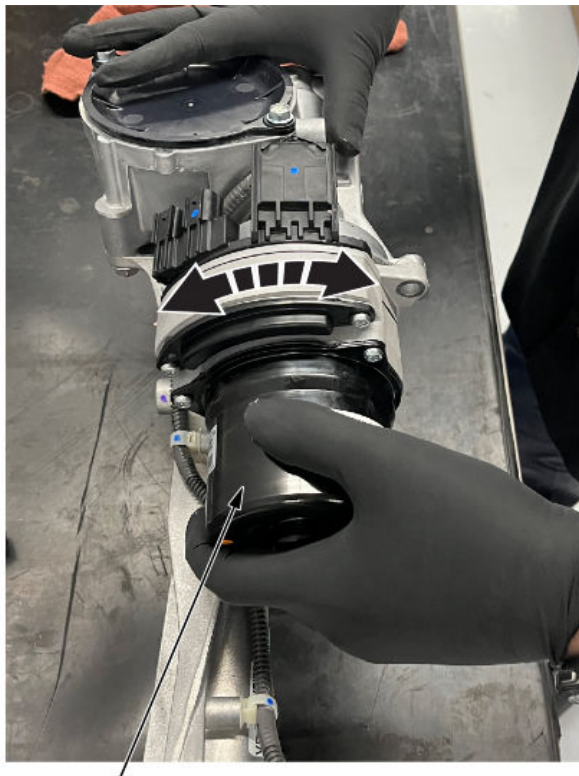
22. Turn the EPS motor/control unit **two or three times** to both the **left and right** in a **45° arc** as shown below.

EPS MOTOR CONTROL UNIT
Turn unit two or three times to the right and left (about 45 degrees).

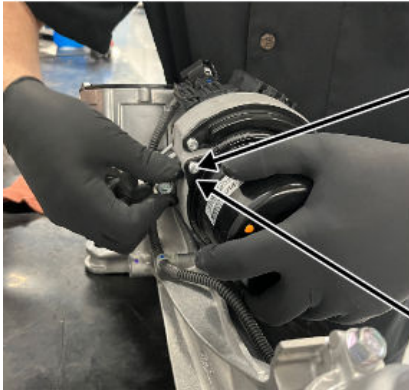
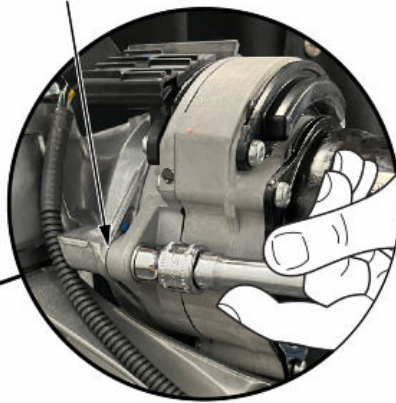
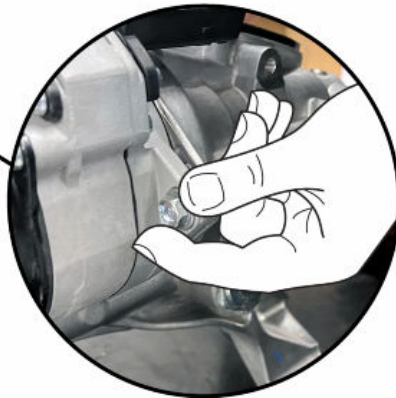
- To prevent damaging the motor and/or gearbox, **DO NOT** use power tools to install or tighten the bolts.
- Make sure the EPS motor/control unit is evenly seated on the P/S gearbox.

EPS MOTOR/CONTROL UNIT
Make sure unit is evenly seated.

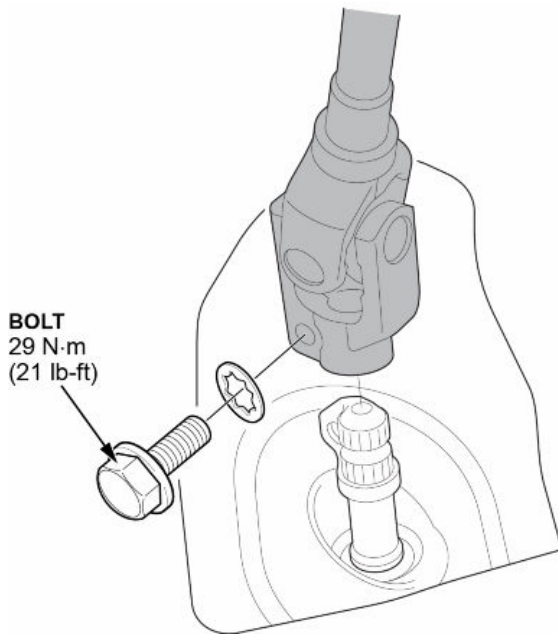
27. Install the pinion shaft to the steering joint **29 N·m (21 lb-ft)**.
