Part 573 Safety Recall Report

24V-124

Manufacturer Name : Toyota Motor Engineering & Manufacturing**Submission Date :** FEB 21, 2024**NHTSA Recall No. :** 24V-124**Manufacturer Recall No. :** 24TA01 / 24LA01

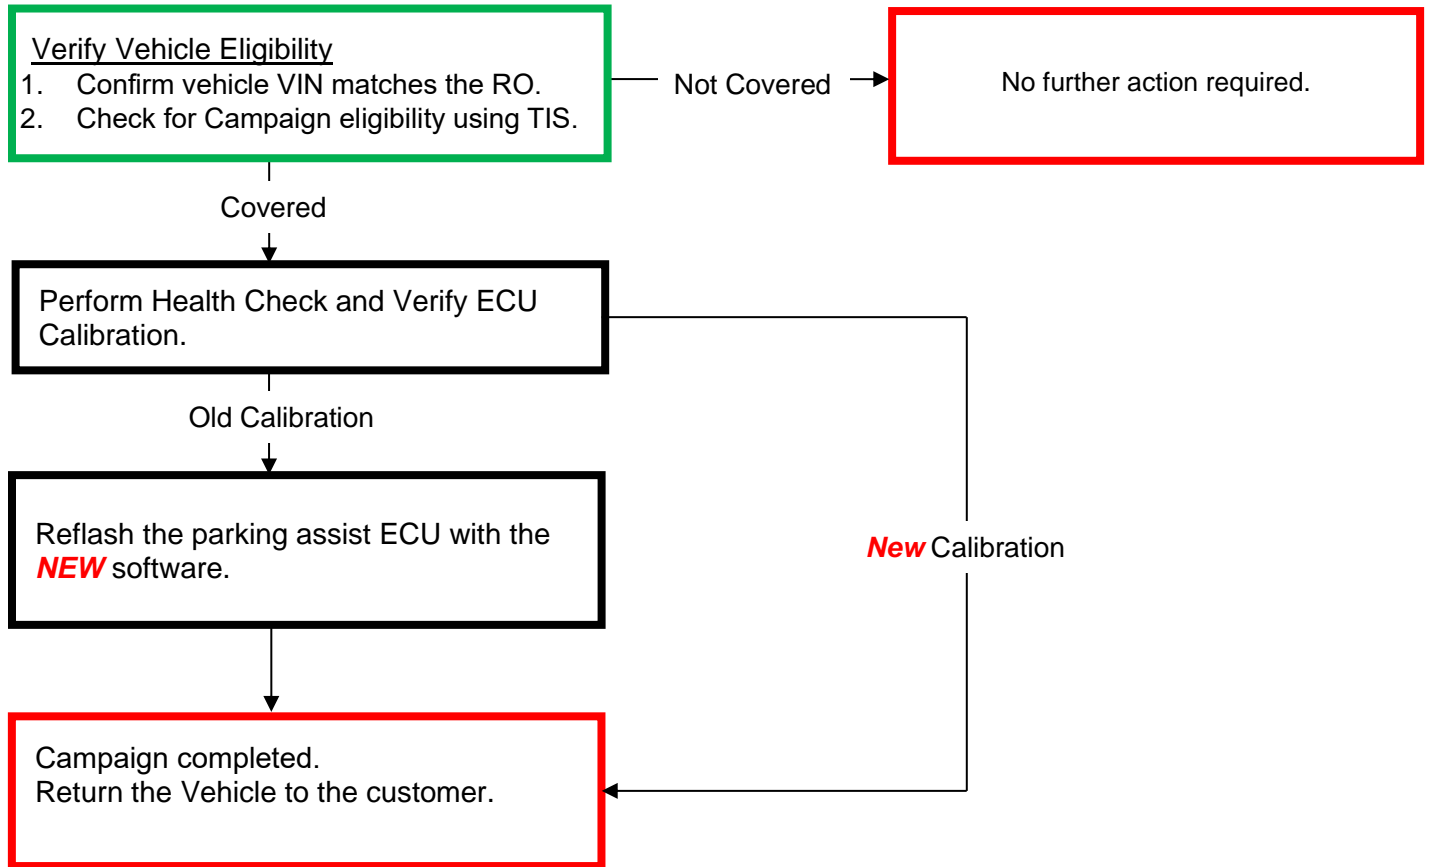
I. OPERATION FLOW CHART

The flow chart is for reference only. **DO NOT** use it in place of the full technical instructions. Follow **ALL** steps as outlined in the full technical instructions to confirm the campaign is completed correctly.
