2016

Tested Model	Toyota Hilux Double-Cab, 2.4 diesel 4x4, mid grade, LHD
Safety pack	Toyota Safety Sense
Body Type	- Pickup
Year Of Publication	2016
Kerb Weight	2050kg
VIN From Which Rating Applies	- Hilux double-cabs with optional 'Toyota Safety Sense'
Class	Pick-up

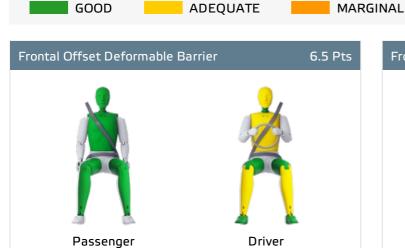
The passenger compartment remained stable in the frontal offset test. Dummy readings showed good protection of the knees and femurs of the driver and passenger. Toyota showed that a similar level of protection would be provided for occupants of different sizes and to those sat in different positions. The driver's airbag was insufficiently inflated to prevent 'bottoming out', and the head contacted the steering wheel through the airbag material. Although dummy readings were not hazardous, the score was penalised and protection rated as adequate. Protection of the passenger dummy was good for all critical body areas. In the full width rigid barrier test, protection was good except for the chest of the front seat driver, protection of which was adequate and the chest of the rear seat passenger, protection of which was marginal. In both the side impact barrier test and the more severe side pole impact, the Hilux scored maximum points with good protection of all critical body regions. Likewise, tests showed that the whiplash protection provided by the front seats and head restraints was good in the event of a rear end collision and a geometric assessment of the rear seats indicated good protection there also. Increased whiplash protection is provided by an autonomous emergency braking system, available as part of the option pack. The system performed well in tests at the low speeds typical of city driving at which many whiplash accidents occur.
